ASSESSMENT OF THE TECHNICAL CONDITION OF STEEL-REINFORCED CONCRETE FLOORS OF WORKING TOWERS OF GRAIN STORAGE FACILITIES

Abstract. This paper examines the technical condition assessment of steel-reinforced concrete floors in grain elevator working towers through comprehensive inspection methods applied prior to commissioning. The research focuses on evaluating construction quality, identifying defects, and validating structural integrity using advanced non-destructive testing techniques. Particular attention is given to detecting hidden imperfections such as voids, adhesion failures, and early-stage corrosion that may compromise long-term performance and safety under operational dynamic loads from grain cleaning equipment.

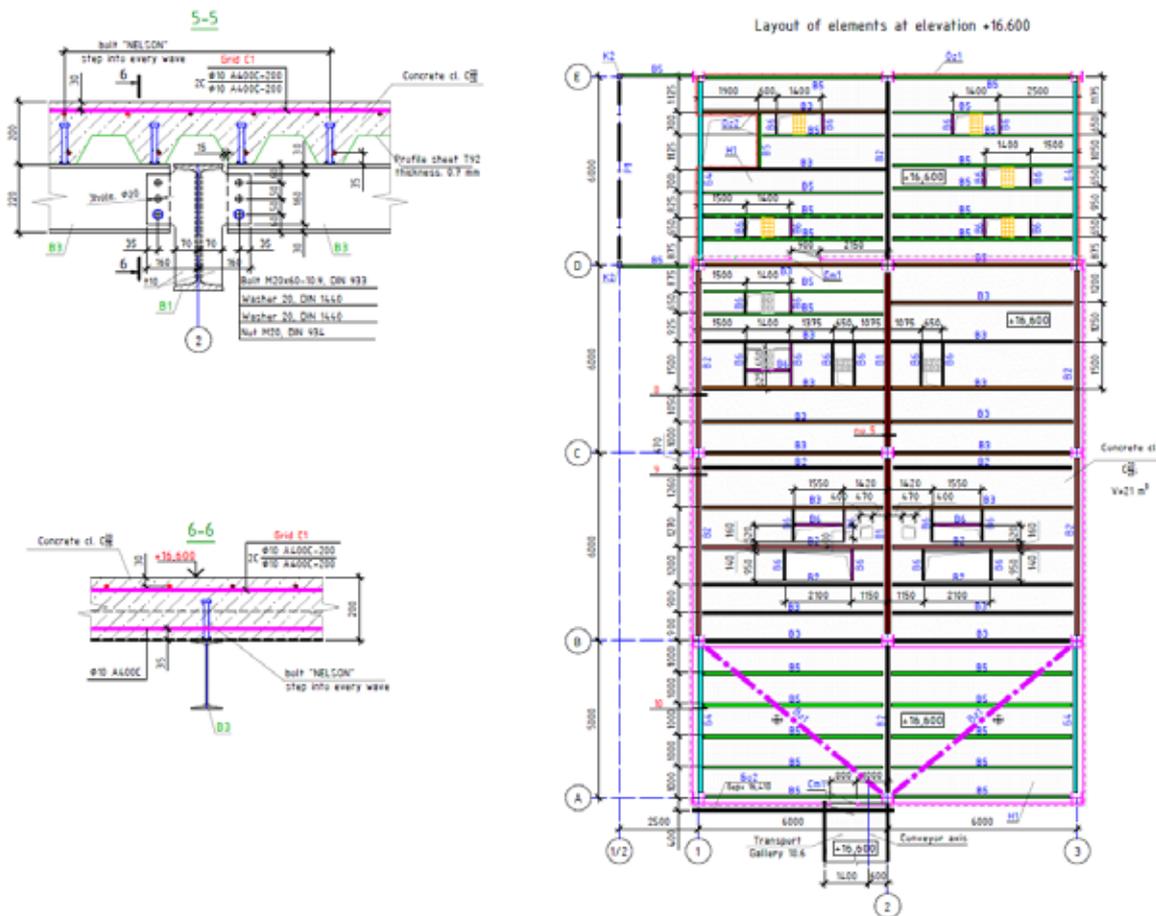
Key nodes, including slab-to-beam and beam-to-column connections, were examined in the plan view and fragments (Fig. 1) to confirm stud spacing, beam profiles, and plate layout.

Fig. 1. Connection details and plan layout of the separator floor at elevation +16.600 m

Discrepancies between drawing specifications and on-site conditions – such as slight variations in connector layout or reinforcement cover – were noted and used to guide subsequent inspection points and interpret measurement results.

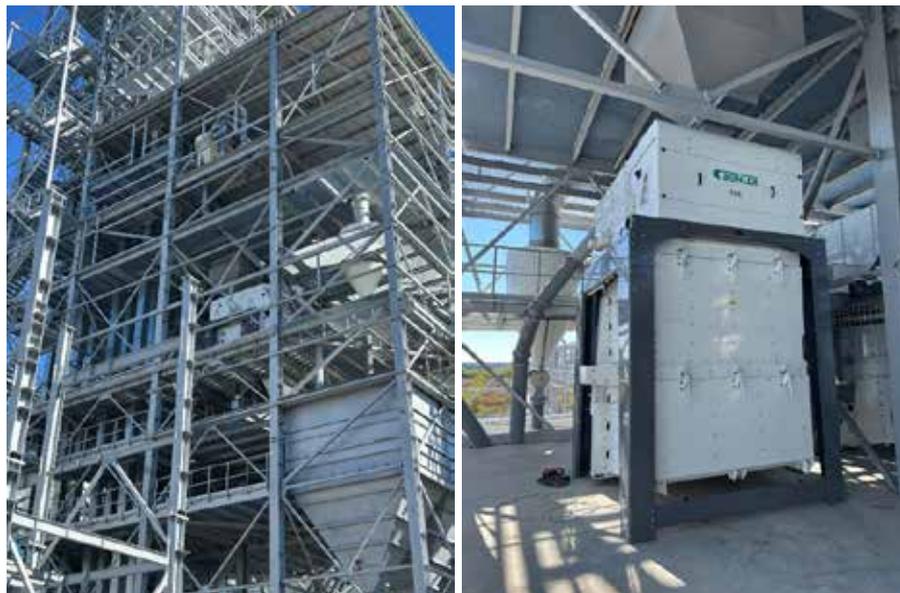
As a result of the detailed inspection of the steel-reinforced concrete floor at the separator level of the elevator working tower, a full visual survey with photographic documentation was carried out alongside a suite of instrumental measurements (Fig. 2).

Fig. 2. Exterior view of the elevator working tower frame (left) and grain cleaning separator installed on the composite floor (right), within axis «1-2», «B-C» at elevation +16.600 m

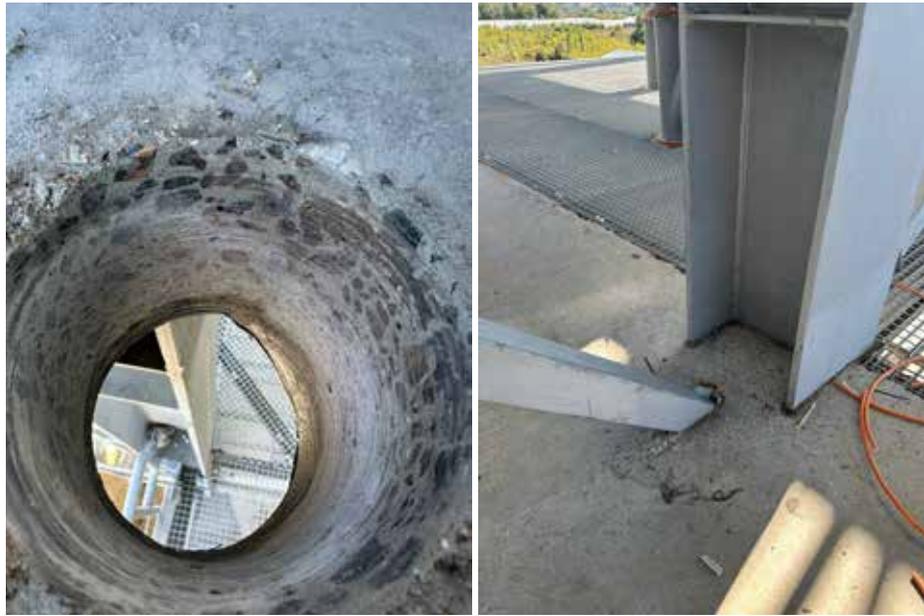
Thickness measurements taken at 12 control points approved the concrete slab conforms to the design thickness of 150 mm within a ± 5 mm tolerance. Geometric checks of the I-section steel beams (I22, I30 and I40) matched the technical drawings. Visual inspection [8] revealed isolated microcracks up to 0.2 mm width adjacent to equipment anchorage zones and at slab-to-column joint areas (Fig. 3), all defects were recorded photographically for further analysis. During inspection additionally we used infrared scanning to localize areas of differential heat flow indicative of hidden defects. Infrared thermography flagged the Nelson [15] stud connection zones as exhibiting slight temperature differentials relative to surrounding areas, suggesting potential adhesion issues or early-stage corrosion of the connectors. The remainder of the floor displayed a uniform thermal profile, indicating no additional hidden defects. Laboratory testing of core samples verified concrete class C25/30 with a density

of approximately 2400 kg/m³ [19] and showed no significant reinforcement corrosion (Fig. 3). A summary of key measurements was compiled in Table 1.

Figure 3. Core extraction hole in concrete slab (left) for designation strengths of material and localized microcracking, width of cracks 0.2 mm at point of connection main beams, brace and column (right), at intersection axis «2-C» at elevation +16.600 m

Ongoing periodic monitoring is recommended, particularly in high-stress zones.
